## MAINTENANCE ACTIVITY REPORT

**Site Name/Facility:** Lower Alvarado channel  
**PEIR Map No:** Maps 59 & 60  
**Date:** February 2011  
**Preparer Name:** Rudy Bilan, City of San Diego

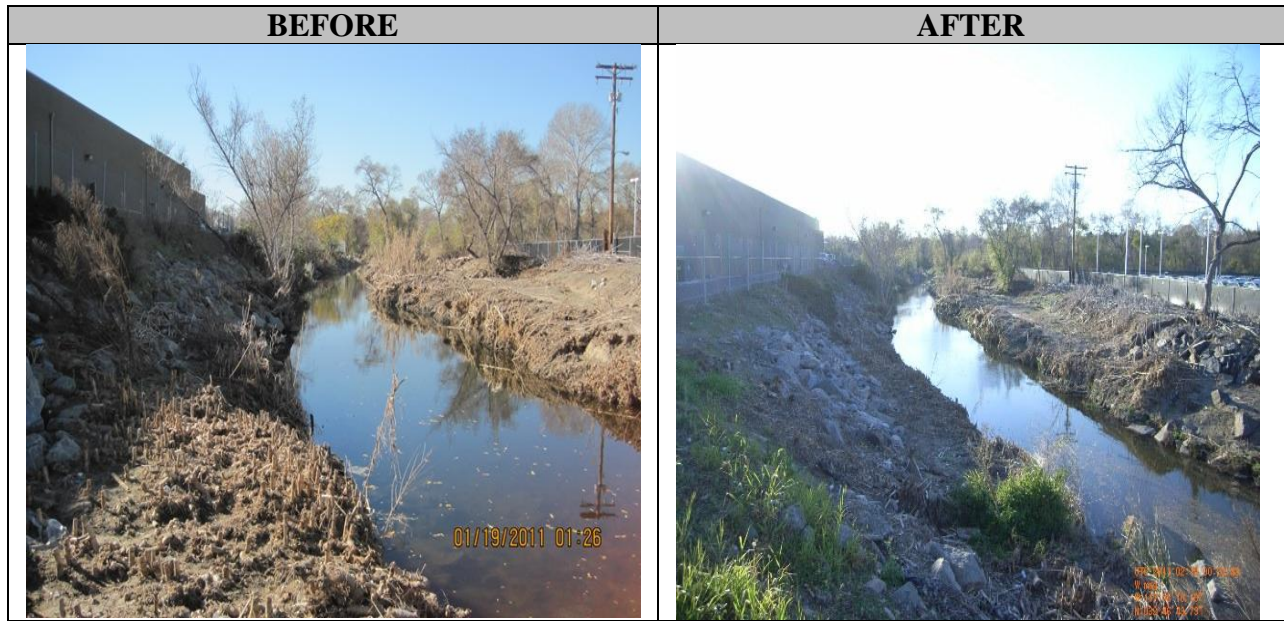
**PHOTO NOTES:** View from midpoint of west boundary of Map 59 & Mission Gorge Road Bridge (MGRB).  
Looking downstream in western direction.

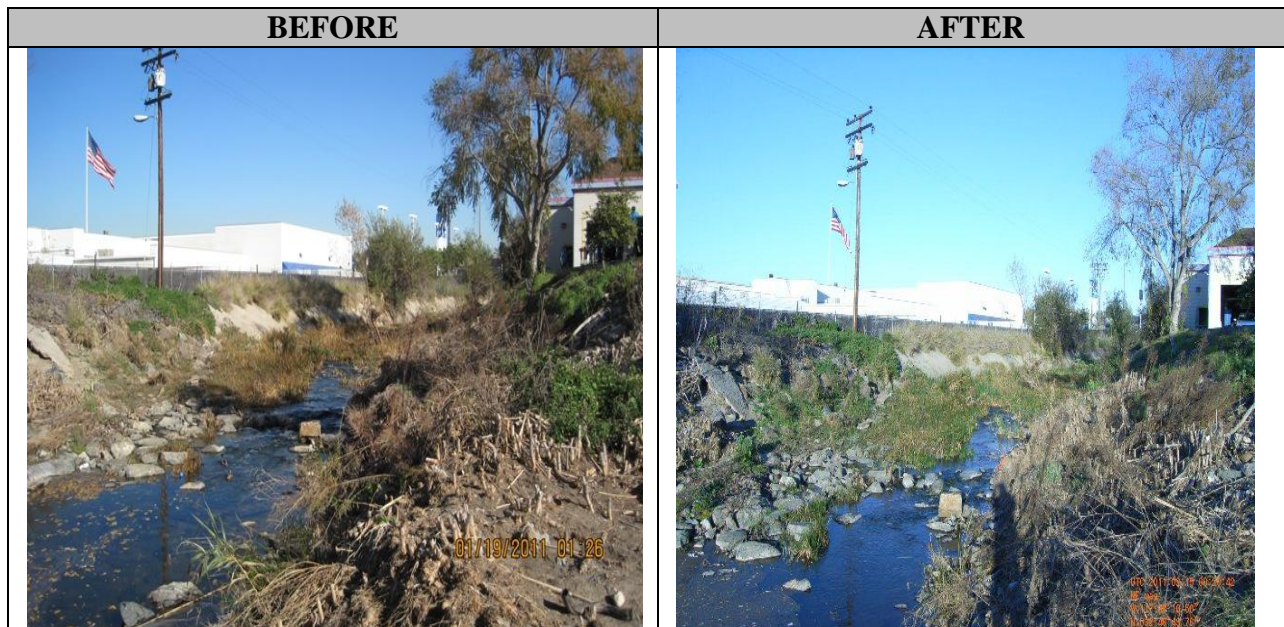
**PHOTO NOTES:** View from midpoint of west end of Map 59 and MGRB. Looking upstream in eastern direction.

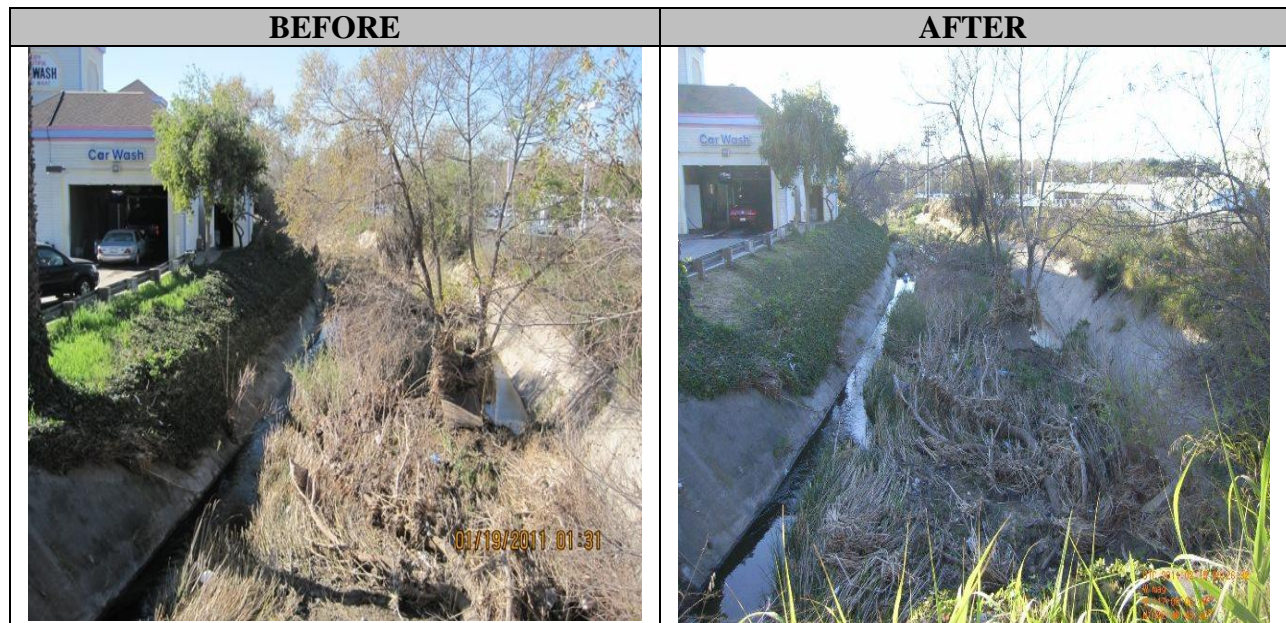
**PHOTO NOTES:** View looking downstream in western direction from MGRB.

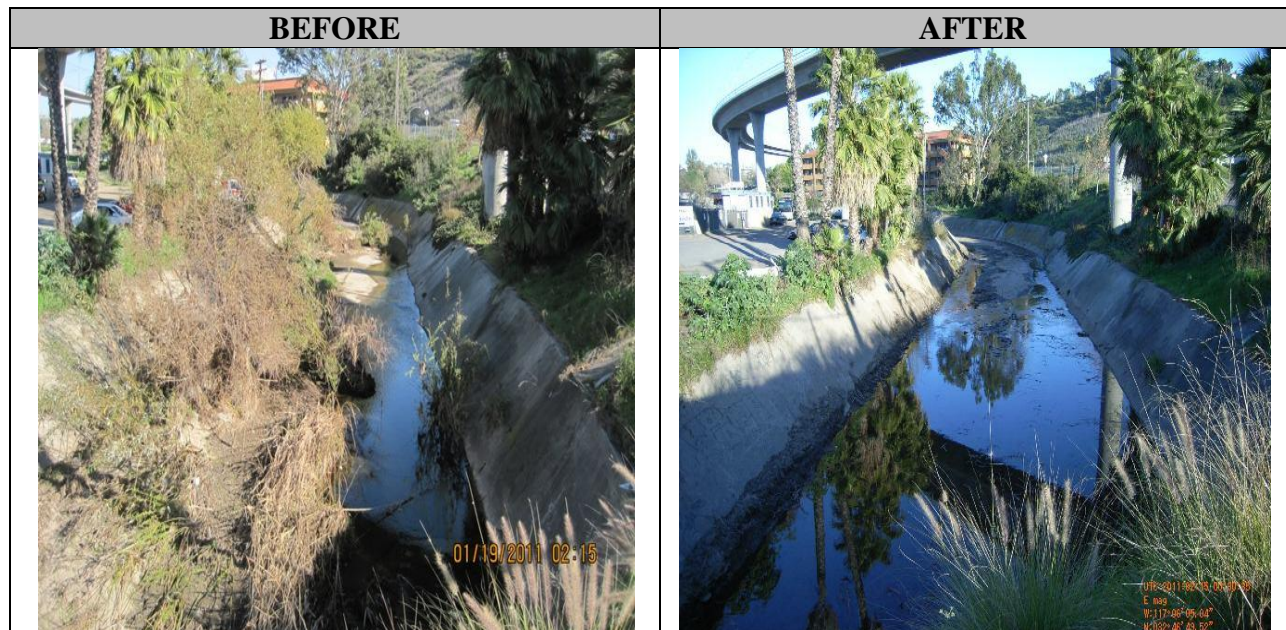
**PHOTO NOTES:** View looking upstream in eastern direction from MGRB.

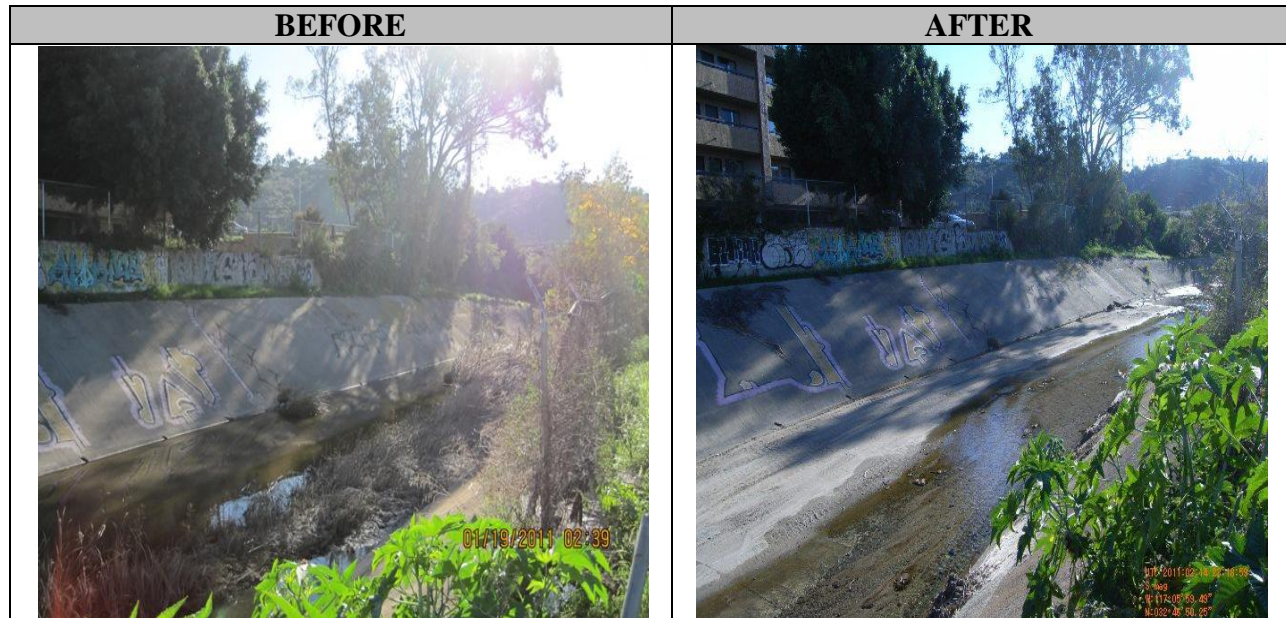
**PHOTO NOTES:** View from about twenty feet from end of concrete lined channel and start of earthen channel at a segment between auto repair shop and hotel near MGRB. Looking downstream towards east side of MGRB.

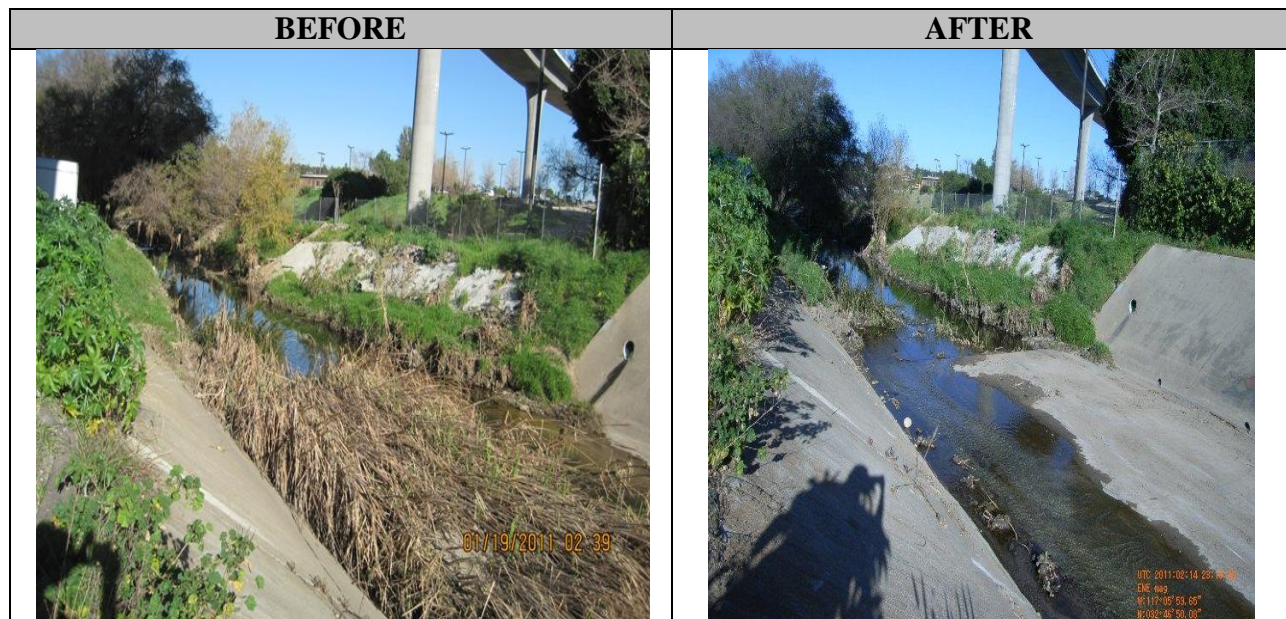
**PHOTO NOTES:** View from about twenty feet from end of concrete lined channel & start of earthen channel. This segment is between auto repair shop and hotel near MGRB (east side). Looking upstream in eastern direction.

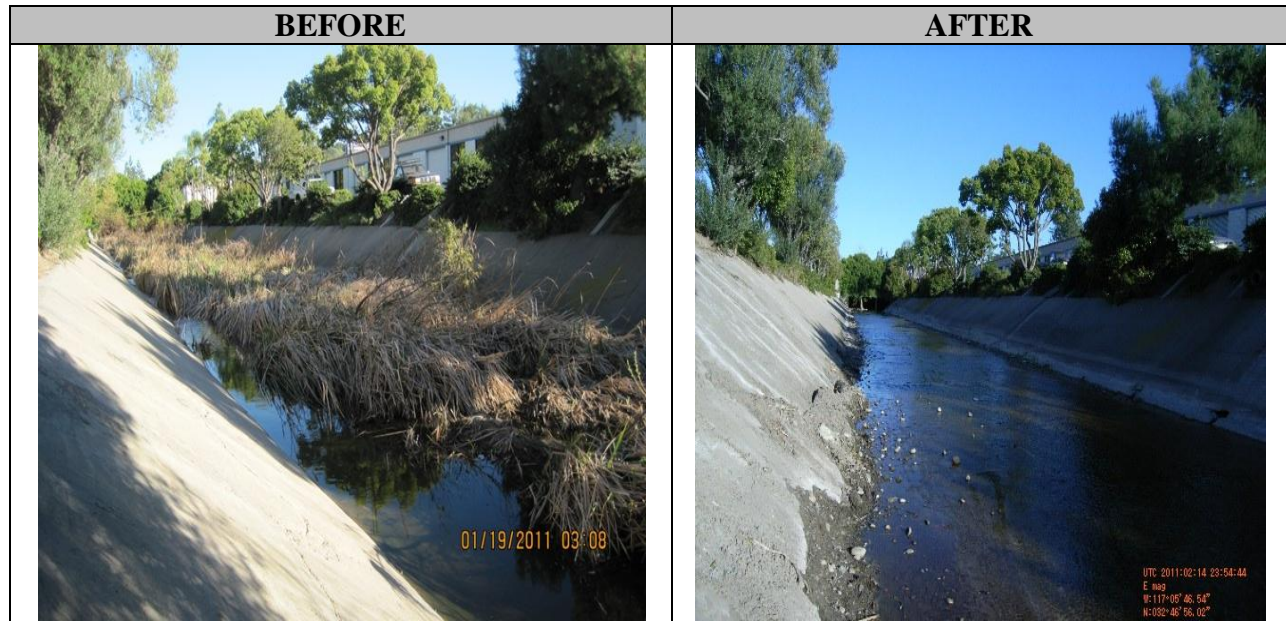
**PHOTO NOTES:** View from access point to box drain culvert at east end of map 60. Looking in eastern direction towards box drain culvert.

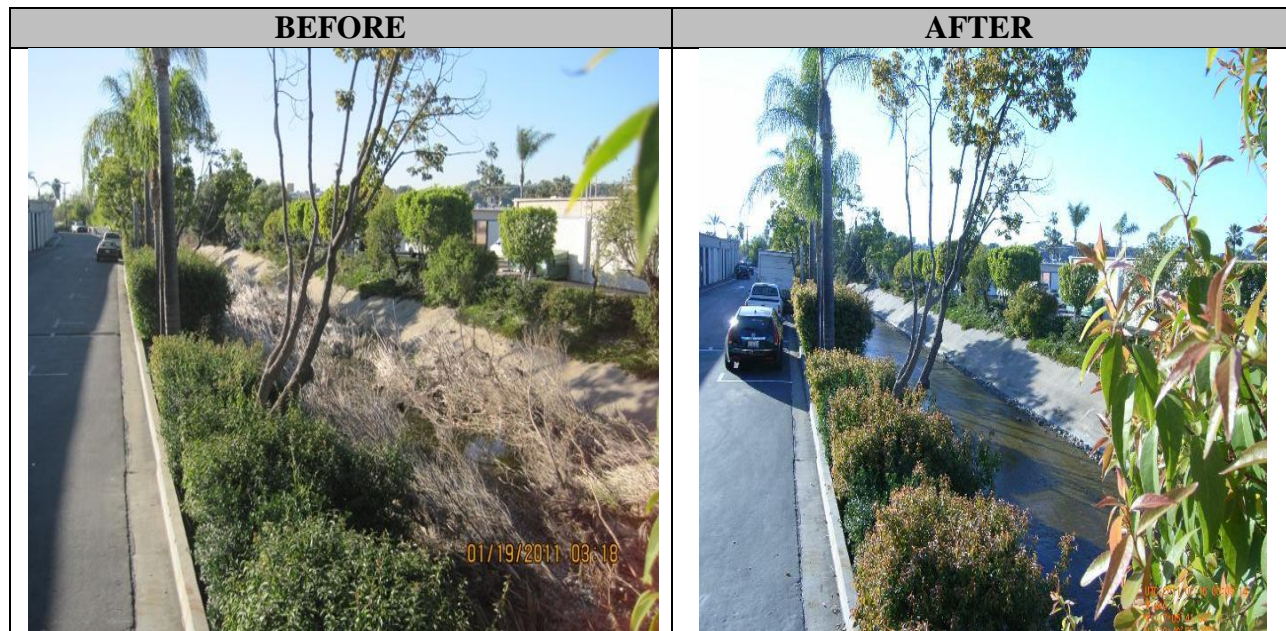
**PHOTO NOTES:** View from south side of channel next to box drain culvert at east end of Map 60 Looking downstream in western direction.
